BIG FOUR MINE DAM

WASHINGTON COUNTY, MISSOURI

MO 30729

PHASE 1 INSPECTION REPORT NATIONAL DAM SAFETY INSPECTION

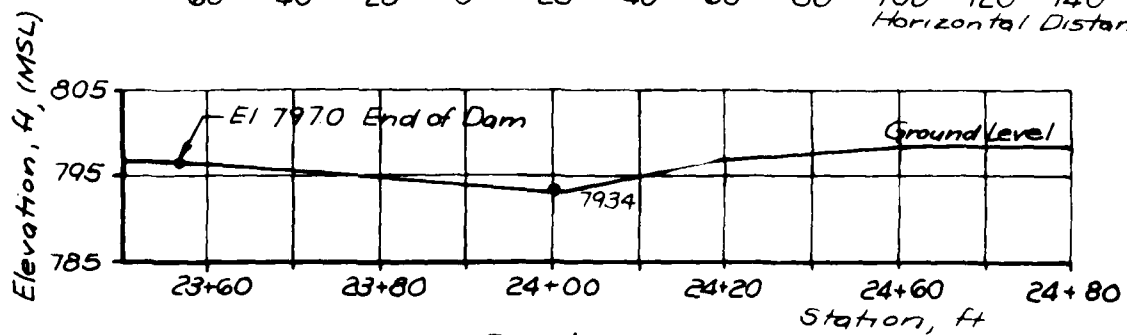
Section B-B
Spillway

- c. **Appurtenant structures.** The spillway is uncontrolled and consists of an earthen channel partially lined with grass at the west end of the dam (see Photos 3 and 4; Appendix A). The soil appears to be moderately erodible. There are no observed conditions which would result in spillway blockage.
